Full-Mouth Rehabilitation of a Patient with Gastroesophageal Reflux Disease: A Clinical Report

Juanli Guo, DMD, MS, PhD, FACP,¹ Glenn Reside, DMD,² & Lyndon F. Cooper, DDS, PhD, FACP³

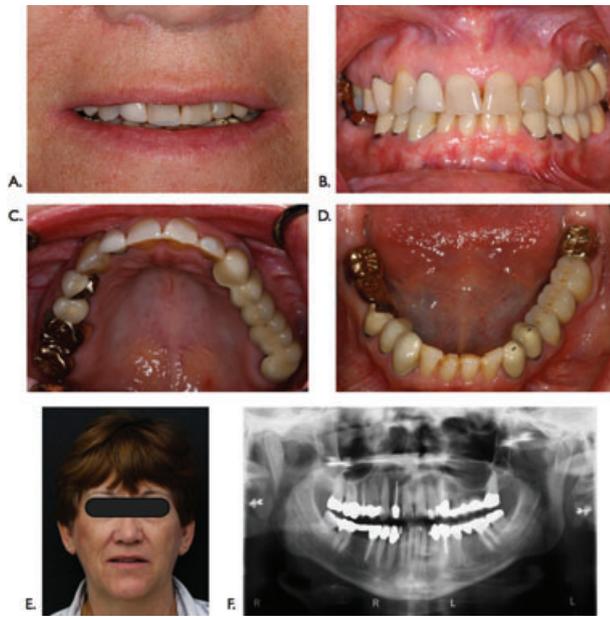
Figure 1 Preoperative images and panoramic radiograph. (A) Close-up frontal view showing thin maxillary incisors. Intraoral images: (B) Frontal view at maximum-intercuspal position (MIP); (C) Maxillary occlusal; and (D) Mandibular occlusal views. (E) Preoperative smile image. (F) Preoperative panoramic radiograph.

Over the past 35 years, the patient had extensive dental treatment, including root canal treatment (RCT), fillings, crowns, and FDPs. The upper-left FDP had been loose for more than 6 months. Clinical exam revealed that a five-unit FDP on teeth #11 to 15 was loose. After removal of the FDP, abutment tooth #11 was noted to have deep caries below the gingival level and was determined nonrestorable. The patient also presented with moderately worn dentition and restorations. Defective composite restorations were present on most of the anterior teeth. Multiple fixed restorations were in place, including porcelain-fused-to-metal (PFM) crowns on teeth #4, 5, 7, 21, 22, 27, and 28, full-gold crowns on teeth #2 and #17, a 7/8 gold crown on tooth #3, a PFM-FDP on teeth #18 to 20, and a gold FDP with mesial retainer facial porcelain veneer on

#29 to 31. Secondary caries was noticed on teeth #2, 6, 8, 9, 10, 11, 17, 18, 20, and 29. The patient had an Angle’s Class I canine relationship and an Angle’s Class III molar relationship. The mandibular midline was coincident with the facial midline, whereas the maxillary midline was 2 mm to the left. The occlusal vertical dimension (OVD) was deemed reduced after evaluation of esthetics and phonetics. The patient’s centric occlusion and maximal intercuspal position (MIP) were coincident. Radiographic findings revealed generalized mild to moderate bone loss (Fig 1). Using the American College of Prosthodontists’ Prosthodontic Diagnostic Index (PDI) for partial edentulism, the patient was classified as Class IV.⁶

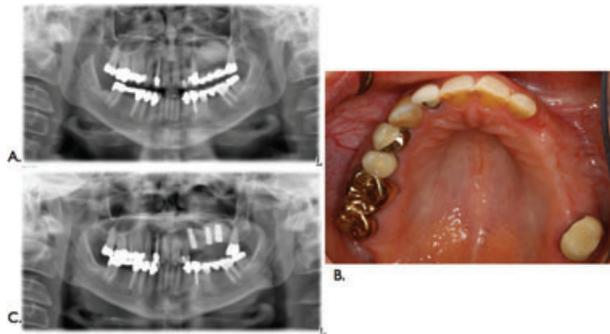
Figure 2 (A) Panoramic radiograph after the lateral window sinus augmentation. (B) Intraoral maxillary view after the sinus augmentation and the ridge augmentation. (C) Panoramic radiograph after implant placement.

window approach sinus floor augmentation was performed, and the grafted area was allowed to heal for 6 months before implant placement. Three months after sinus floor augmentation, the existing FDP #11 to 15 was sectioned at the mesial of abutment tooth #15. The nonrestorable tooth #11 was extracted, and ridge augmentation was completed. An interim PRDP was inserted during healing. After healing of the sinus floor augmentation and the ridge augmentation, three dental implants were placed at #11, 13, and 14 with the aid of a surgical guide (Fig 2).

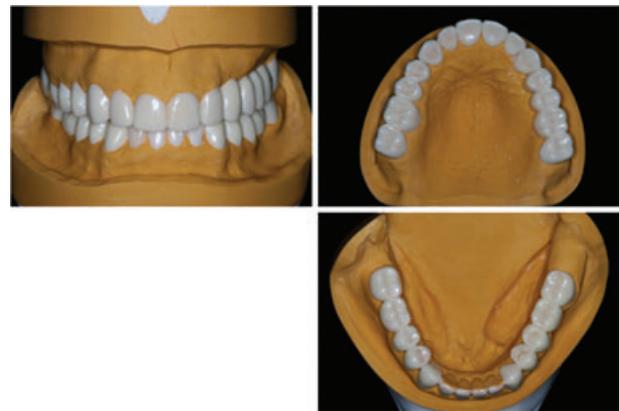
Figure 3 Diagnostic wax-up.

A set of diagnostic casts was made and articulated on a Hanau Wide-View articulator (Waterpik Technologies, Fort Collins, CO) using a Hanau Springbow and a centric relation record. Diagnostic wax-up was done to plan the anticipated occlusion and to foresee any potential problems (Fig 3). OVD was restored by opening about 1.5 mm on the incisal guide pin to compensate the lost OVD.

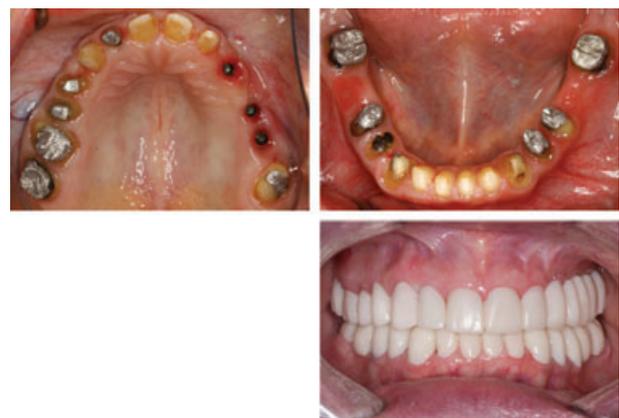
Figure 4 Tooth preparations and interim prostheses.

During the healing of bone grafting and implant surgery, all defective restorations on teeth #6 to 10 and #23 to 26 were removed, and secondary caries excavated. The cavities were restored with composite resin. All existing crowns and FDPs were sectioned and removed. All abutment teeth were thoroughly examined, and secondary caries excavated. Tooth #17 had lost extensive tooth structure and was extracted due to nonpredictable RCT. Teeth #2 and 20 had lost extensive tooth structure, and were recommended to have selective RCT and dowel-core buildup before new crowns were fabricated. Teeth #3, 4, 18, 20, 21, and 31 did not have enough remaining coronal tooth structure for adequate ferrule effect. Therefore, crown-lengthening surgery was recommended. Teeth #3, 5, 15, 18, and 31 lost some tooth structure, but were determined to be restorable and have a favorable prognosis. They were restored with amalgam, with pins placed on teeth #3 and 31 to assist core retention. A cast dowel-core of tooth #21 became loose and was removed. Teeth #2, 4, 7, 20, 21, and 29 were recommended to have RCT. Dowel spaces were prepared on #2, 4, 7, 20, and 21 using a ParaPost XP System (Coltene Whaledent Inc, Cuyahoga Falls, OH). Prefabricated stainless steel ParaPosts was bonded with resin cement (MaxCem Resin Cement, Kerr Corporation, Orange, CA), and the teeth were then restored with amalgam. Tooth #29 had adequate tooth structure after RCT and was restored with amalgam. The preparations were refined. Provisional crowns and FDPs were fabricated using autopolymerized acrylic resin.

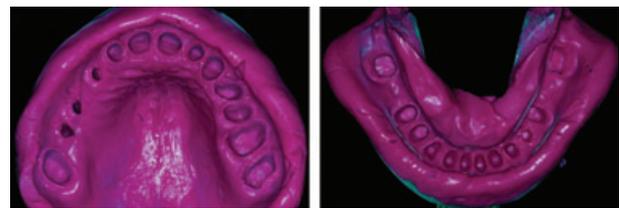
Figure 5 Final impressions.

The implants were uncovered during second stage surgery after 3 months healing, and a screw-retained provisional FDP was fabricated at #11 to 13–14 area. Teeth #6 to 10 were prepared for zirconium-based all-ceramic crowns. Teeth #23 to 26 were prepared for Empress all-ceramic crowns (Ivoclar Vivadent, Amherst, NY). A set of new provisional crowns and FDPs was fabricated and delivered at the increased OVD (Fig 4). After the patient felt comfortable with the new interim prostheses for a month, impressions of the interim prostheses were made, and casts were poured (Fig 5). Casts were mounted on a Hanau Wide-View semi-adjustable articulator. A custom incisal guide table was fabricated. Final impressions were made of all prepared natural teeth and implant fixtures with vinylpolysiloxane (VPS) impression material. Centric relation interocclusal records, including preparation against prepara-

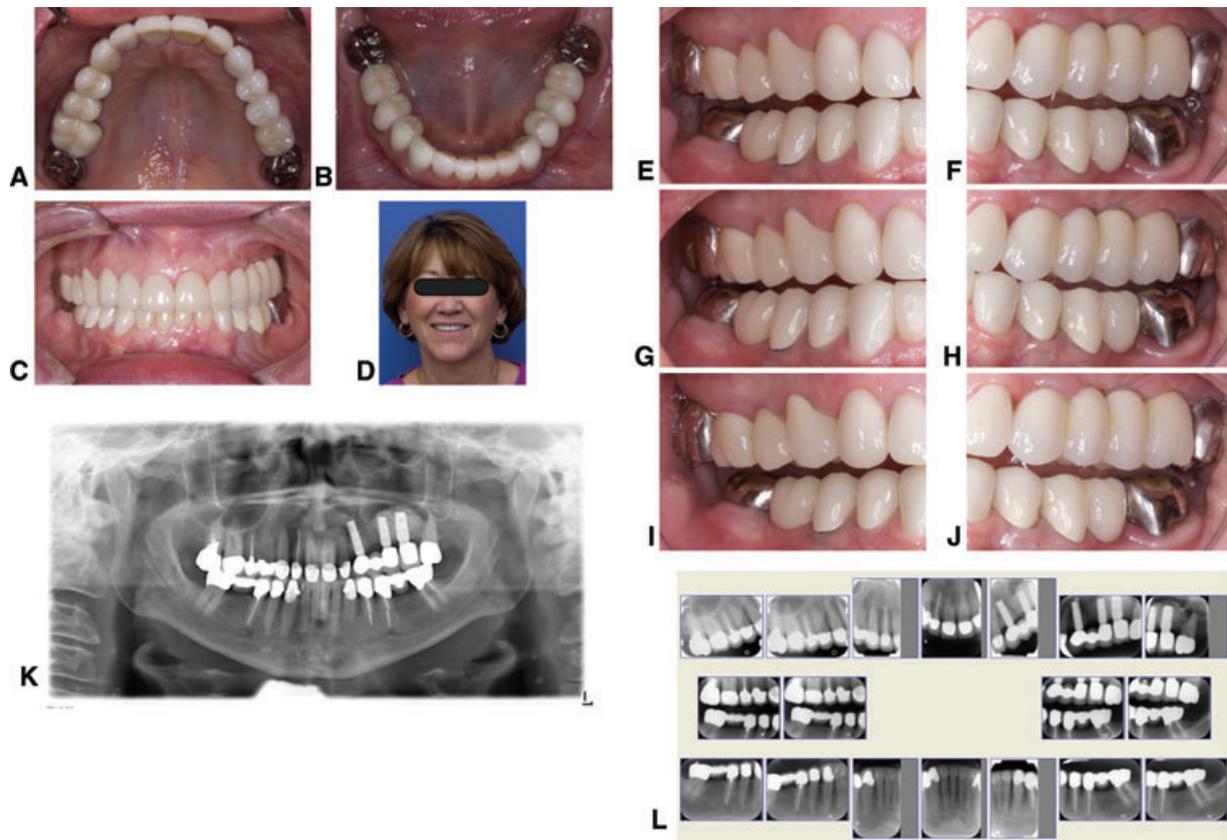
Figure 6 Postoperative images and radiographs. (A) Maxillary occlusal view. (B) Mandibular occlusal view. (C) Frontal view at MIP. (D) Patient's facial frontal smile view. (E, F) Lateral view at protrusion. (G, H) Lateral view at laterotrusion. (I, J) Lateral view at mediotrusion. (K) Postoperative panoramic radiograph. (L) Postoperative full-mouth series radiograph.
